Re: Inspection Report for the Commercial Building @ Sample Building

PROPERTY CONDITION REPORT
Commercial Building

Conducted on July 9, 2012

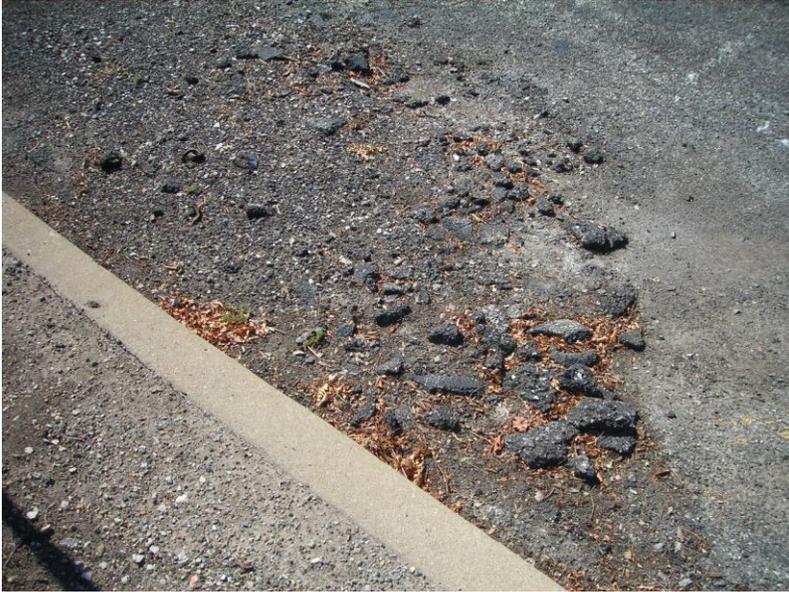
The property is bordered by Parkway on the north. The parking areas are asphalt. There is some extensive cracking and deterioration of asphalt surfaces. Recommend obtaining estimates for the repair or replacement of these materials.

Figure 2 Damage to parking lot at north section.

1. Repair or replace asphalt and seal coat parking areas.
2. Repair/seal water infiltration around front entry
3. Recommend trimming bushes, shrubs and vines away from siding to prevent moisture retention.

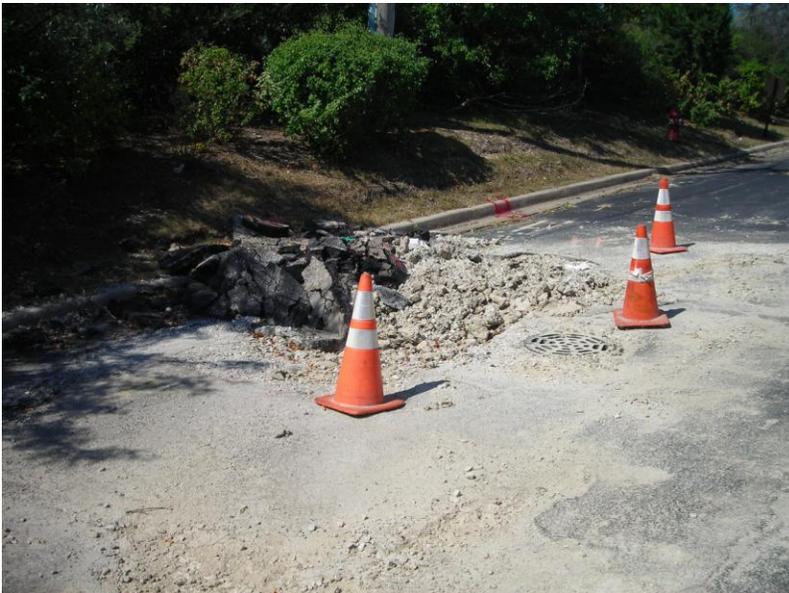
Figure 3 Damage to asphalt at south of building.

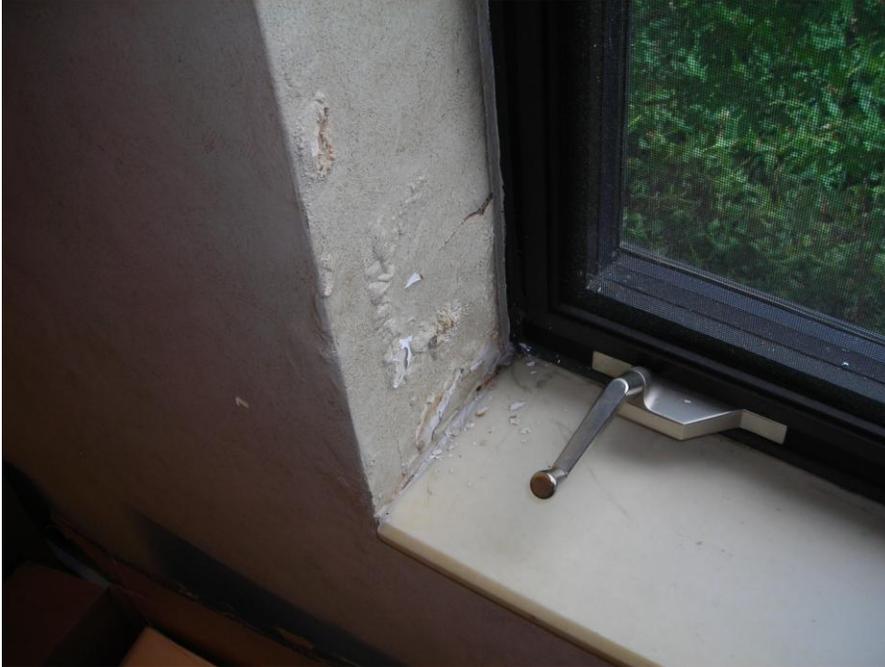
Figure 4 Water damage to west window

1. Seal leaks around windows
2. Repair or replace damaged/loose ceiling insulation

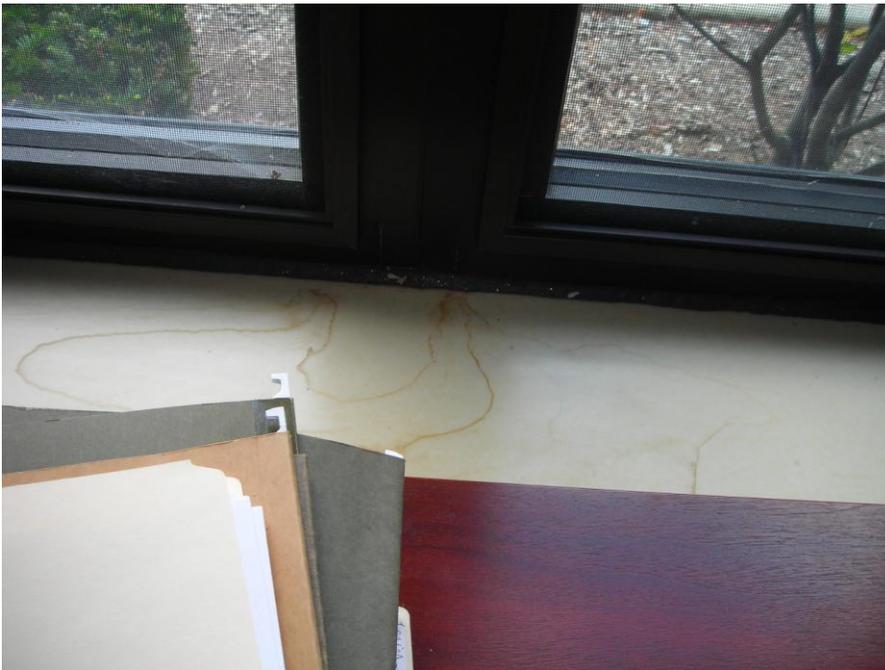
Figure 5 Water stain on north window ledge

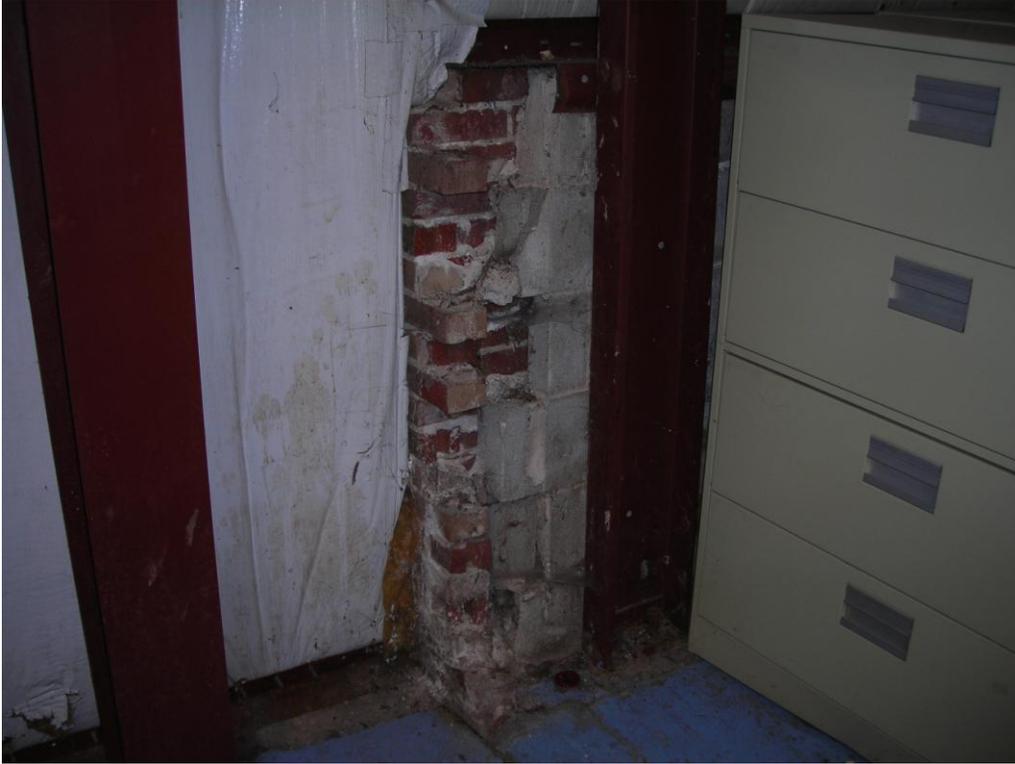
Figure 6 Brick wall to steel wall interface in warehouse. This is an area where insects and vermin can enter building.

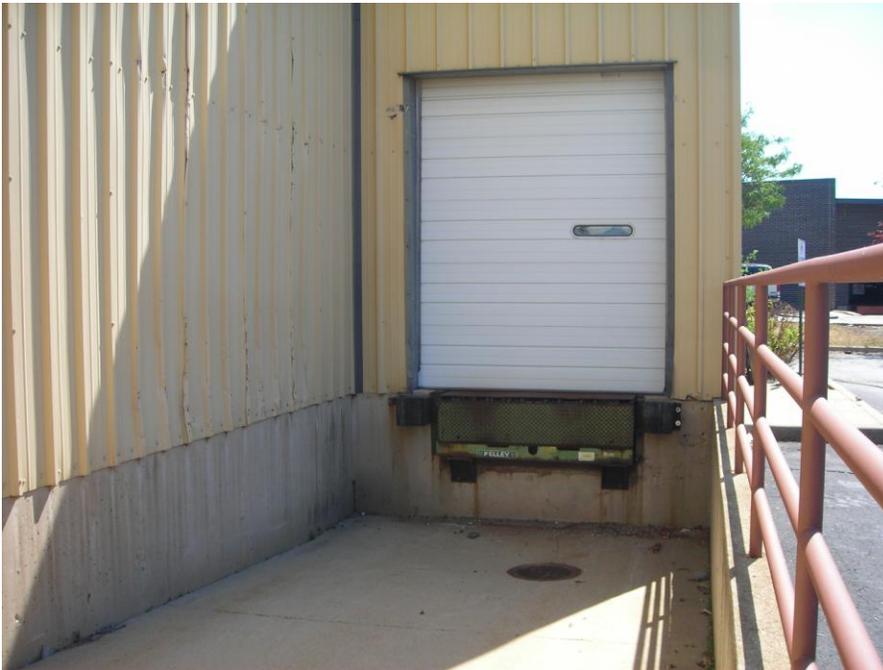
Figure 7 Some damaged steel siding around the dock.

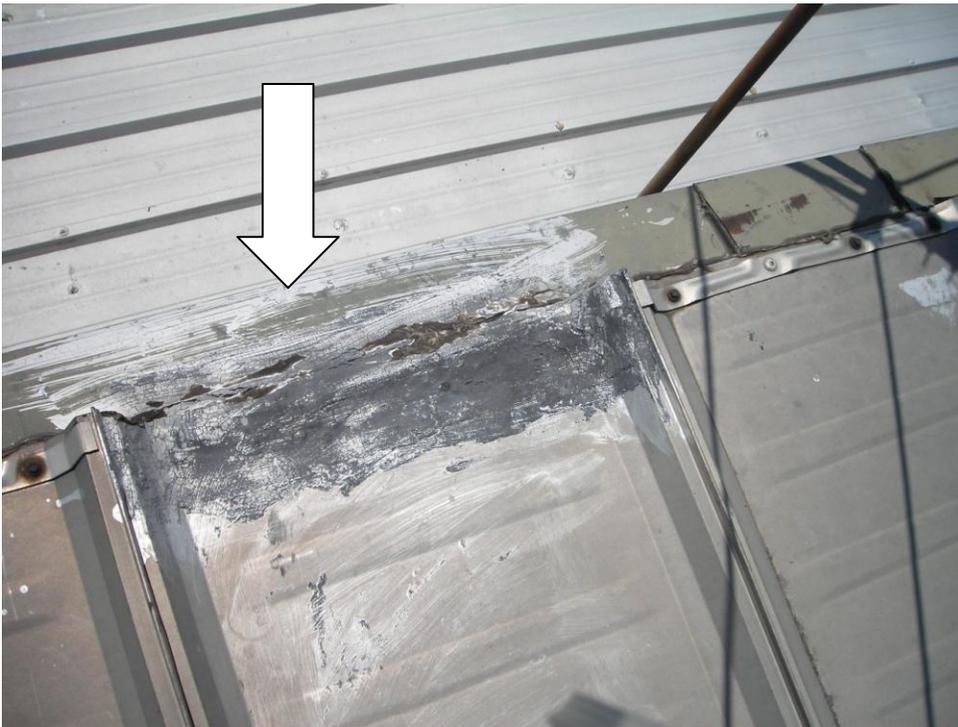
Figure 10 Patched area at south edge of office roof

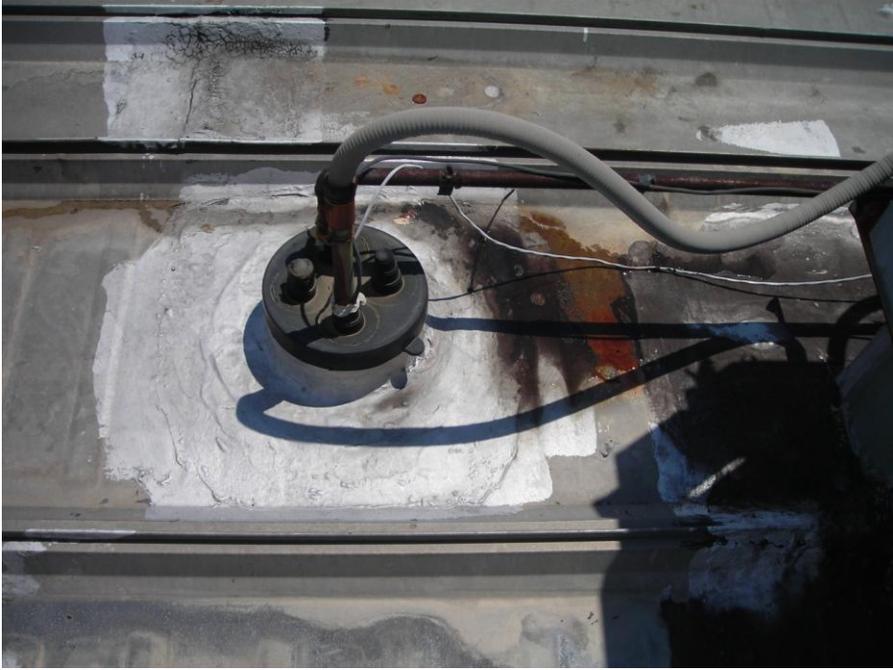
Figure 11 Patched area around penetrations through roof

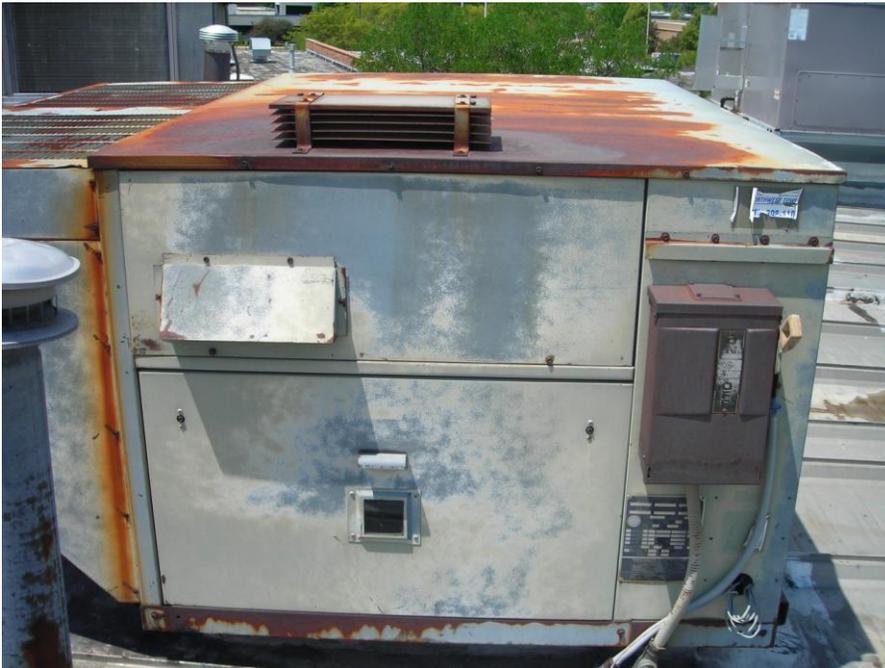
The Trane unit is at the end of its useful life expectancy.

Figure 13 Trane unit. Unit is old and rusted.

Recommend these units be checked by a qualified HVAC contractor and be repaired or replaced as needed.

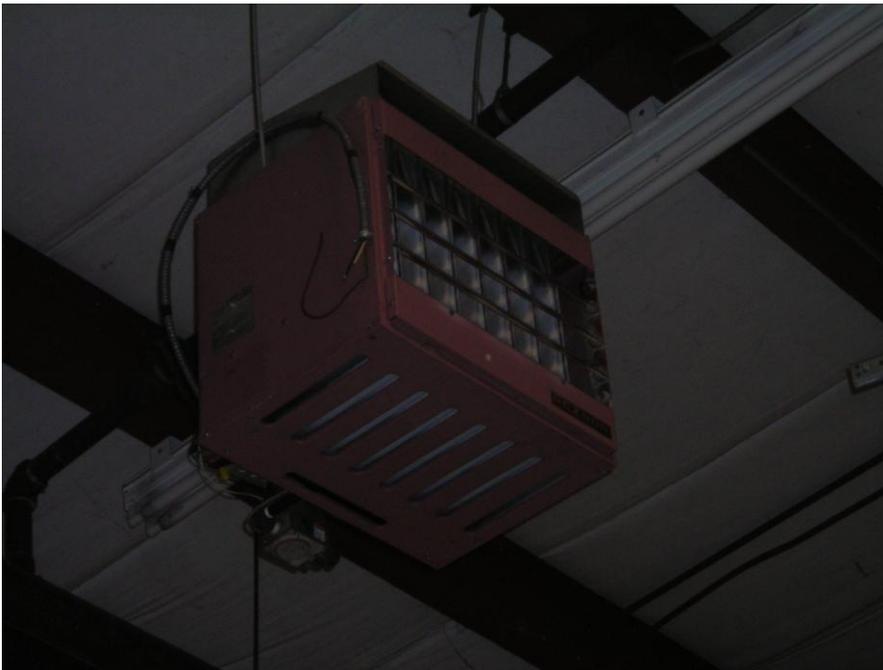
There are 6 hanging gas heaters in the warehouse are. Only one of these was functional at the time of inspection. The unit near south dock door was not connected to gas or electric supply.

Figure 17 Electric not connected to overhead gas heater.

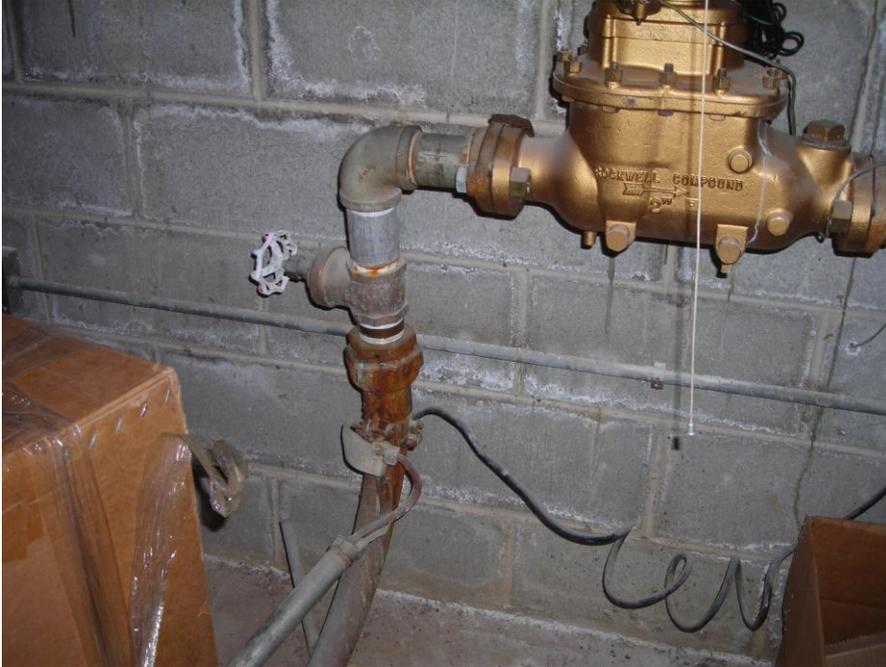
Figure 20 Main water supply. This room is not directly heated. Recommend protect pipes from low temperatures.

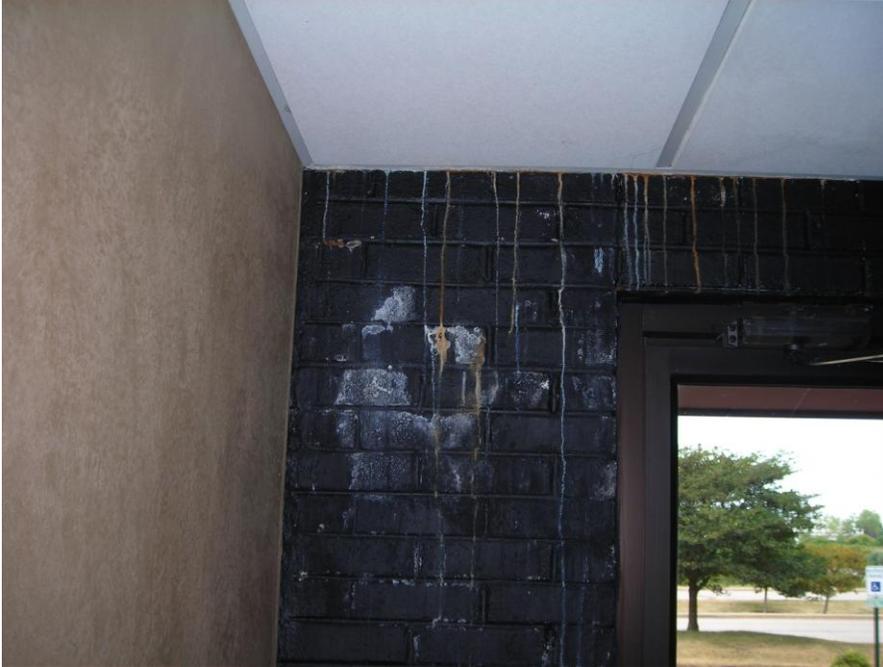
General Structure: The building foundation is of poured concrete slab on concrete footings. There are pest control traps evident around building. No evidence of unusual infestation at the time of inspection. The walls of the building are concrete block and brick. There is evidence of water infiltration around walls of front entry.

Figure 21 Water infiltration in front entry.

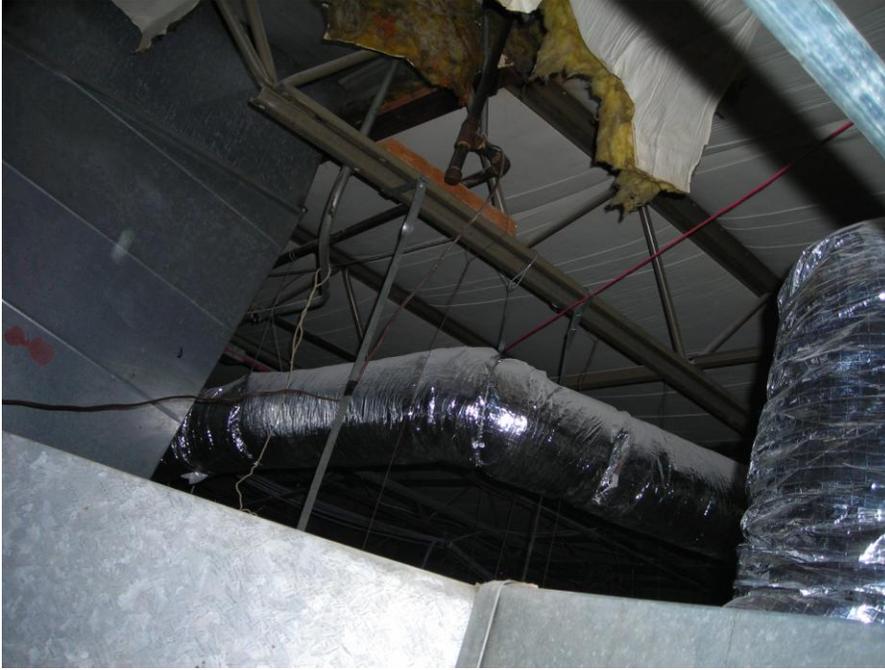
Figure 24 Ceiling area above dropped ceiling tiles. Note loose insulation.
