Re: Inspection Report for the Commercial Building @ Sample Building

PROPERTY CONDITION REPORT
Commercial Building

Conducted on July 9, 2012

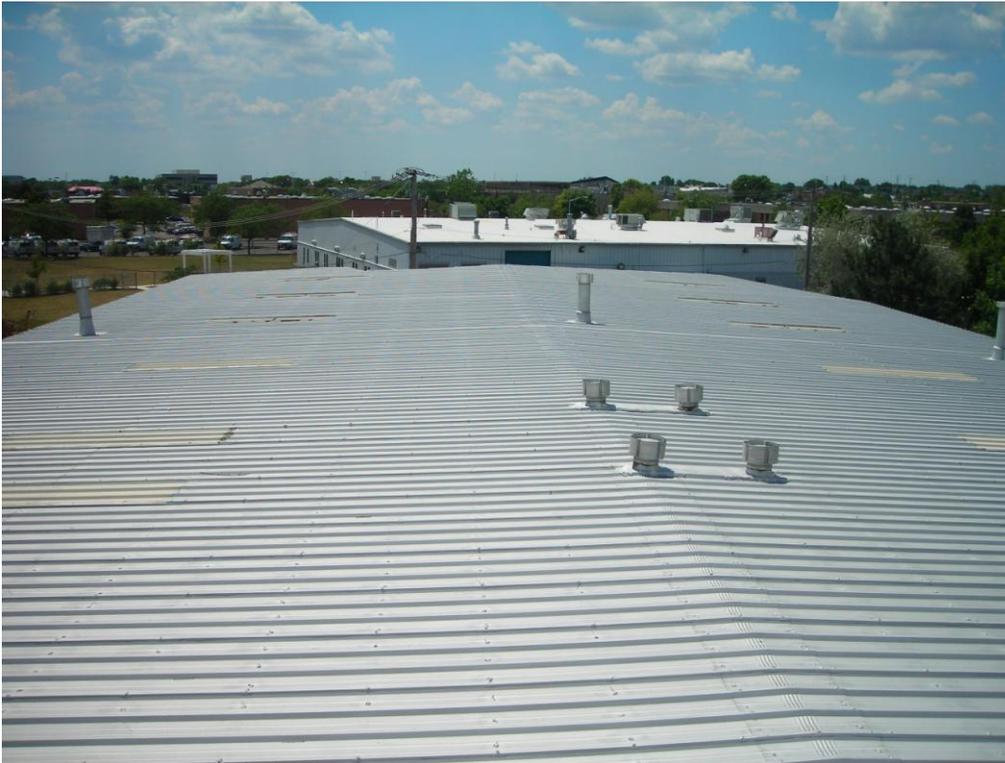
Figure 8 Roof over warehouse

The roof of the building is composed of metal panels over metal trusses. There are some stains and areas that show prior water infiltration, including around north entry and at office to warehouse interface. We could see some patching and repair work done to areas of roof, roof penetrations and parapet walls.

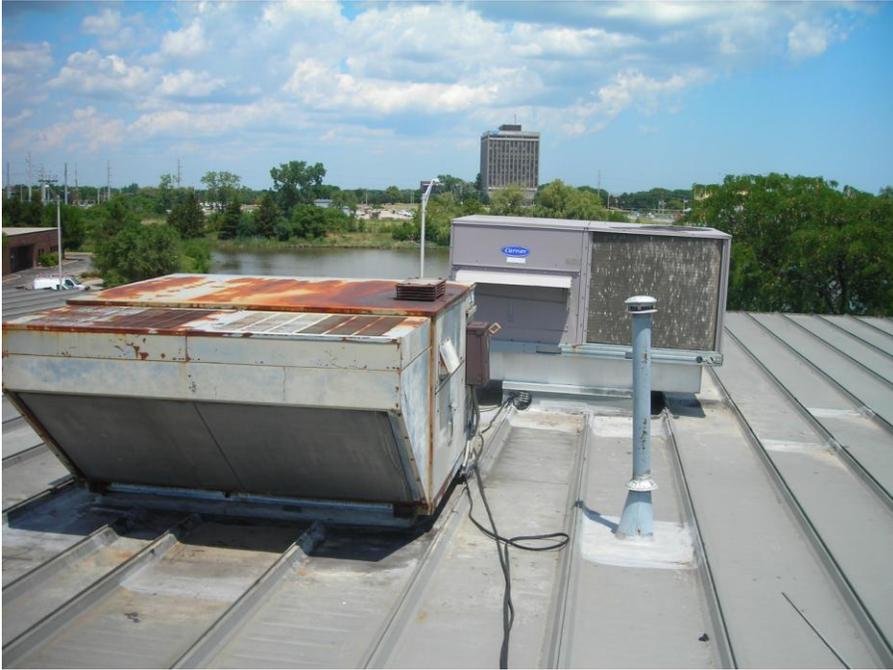
The Trane unit is at the end of its useful life expectancy.

There was condensate draining onto roof from all five units at the time of inspection.

Figure 14 Trane unit and one of Carrier units.

Recommend these units be checked by a qualified HVAC contractor and be repaired or replaced as needed.

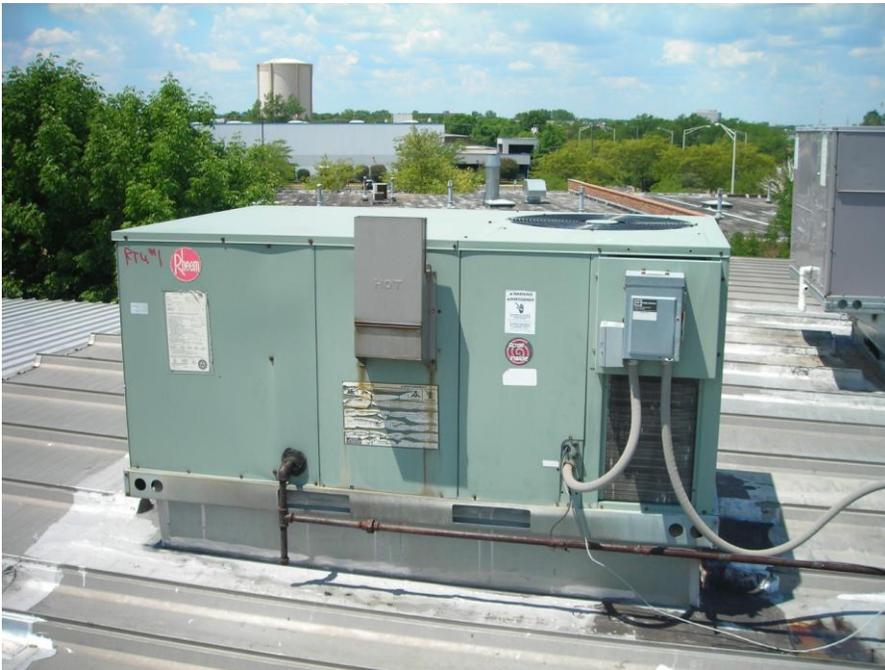
Figure 15 Rheem unit.

1- Rheem unit manufactured 1998. 109,000 BTU's & 4 tons cooling

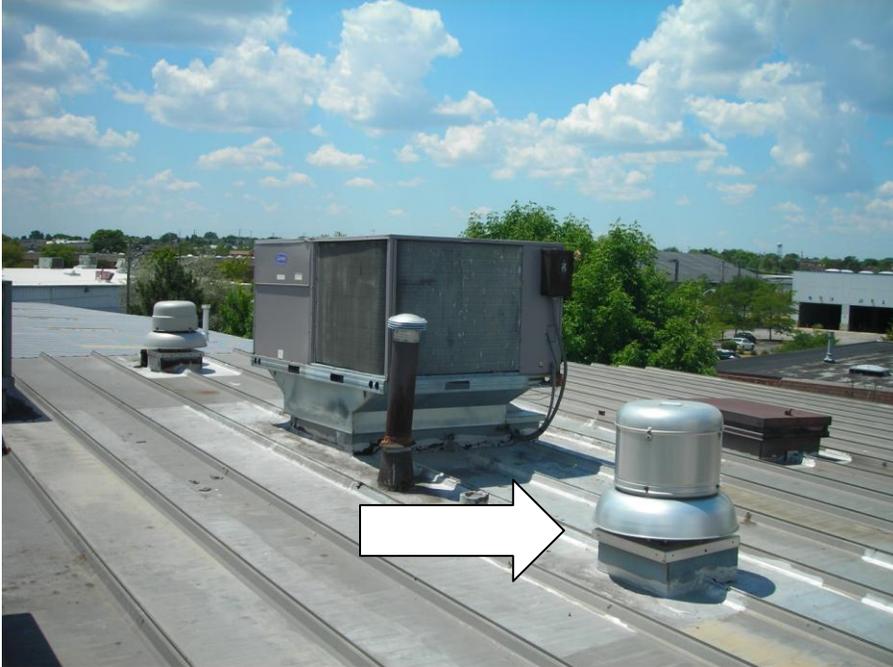
4 tons cooling each. Manufactured between 2000-2005

Figure 16 One Carrier unit with two ventilation fans.

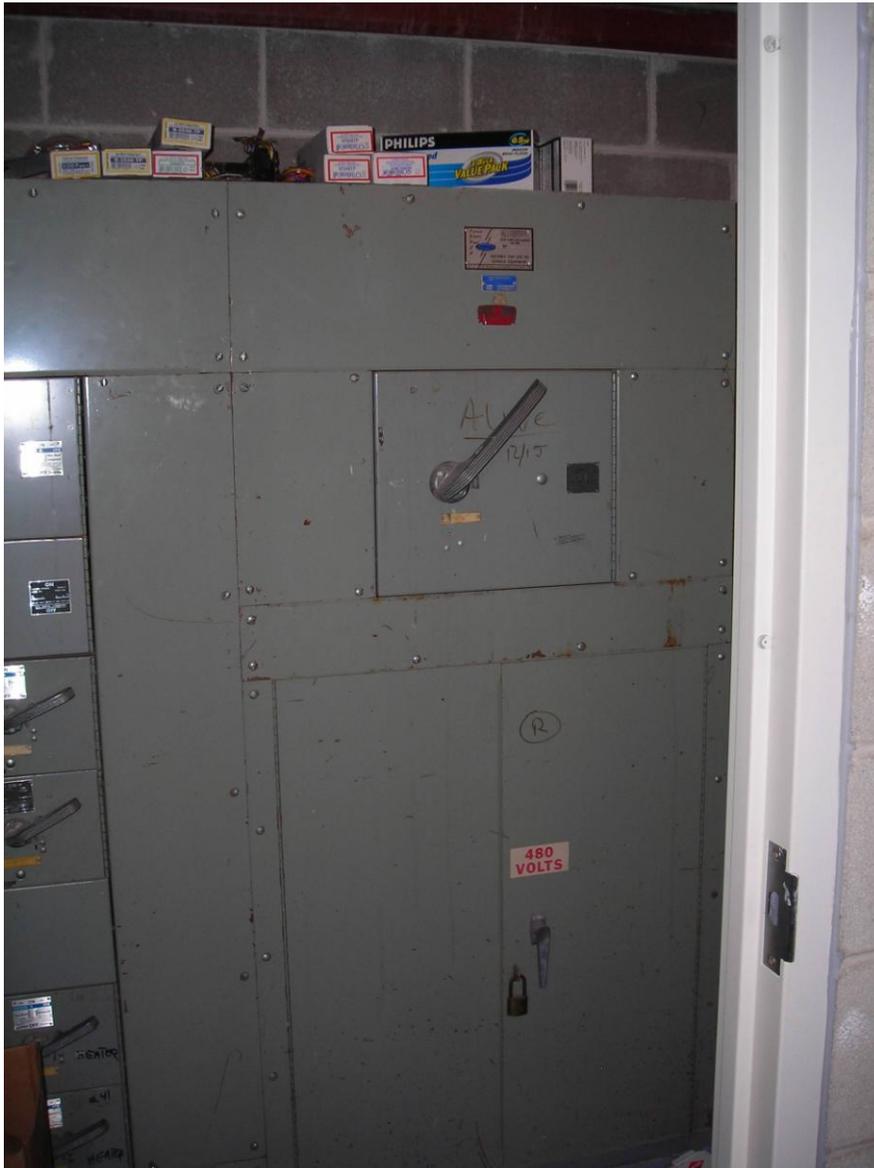
Figure 18 Main electrical panel

This building is serviced by 400 amp, three phase, main service feeder. There are 6 sub panels. The sub panels are connected to transformers to step down the voltage as needed. There is room for expansion in the panels, if needed. There are a few switches, outlets and timer boxes throughout the building that need covers to protect wiring.

All the visible wiring is copper. The electrical system appears professionally installed.

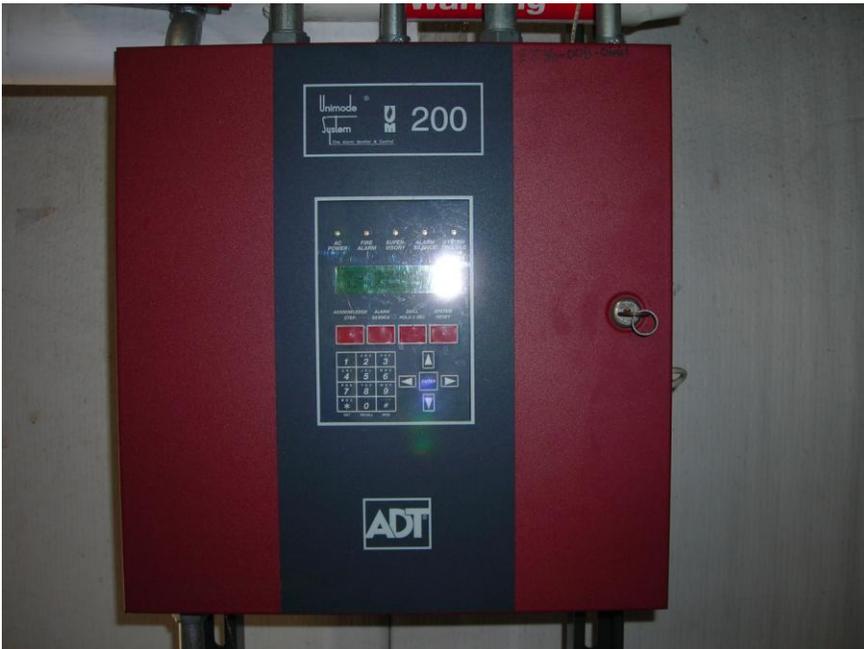
Figure 22 Security system.

The building is equipped with smoke/heat detectors for fire protection. The fire and security systems were not checked or operated as part of this inspection. These systems should be checked regularly for safety and code compliance.
